# Road Safety Case Studies

## ‘Fix Crash Corner’ – A Roundabout Story

Bruno Royce<sup>1</sup>

In 2020, a new roundabout was constructed at the intersection of Church and Victoria Streets, Auckland, New Zealand. It replaced a ‘Stop’ controlled cross-roads junction with adverse crash history, nicknamed ‘crash corner’ by locals, having 54 crashes reported over five years. The constructed roundabout was the first ‘Safe System – Vision Zero’ design of its kind in New Zealand, being a fully raised roundabout with four pedestrian crossings. Independent crash analysis determined that the new roundabout had reduced reported crashes at the junction to zero. The ‘lifetime’ crash cost savings of the new roundabout were estimated at a Present Value of over \$NZ 10 million. The roundabout also improved pedestrian amenity, upgraded access to public transport and local shops, encouraged modal shift, improved social well-being, and helped reduce carbon emissions. The project progressed from scheme design to successful construction within six months, and was selected as a finalist in the IPWEA NZ ‘Asset Management Excellence Awards’ (2022).

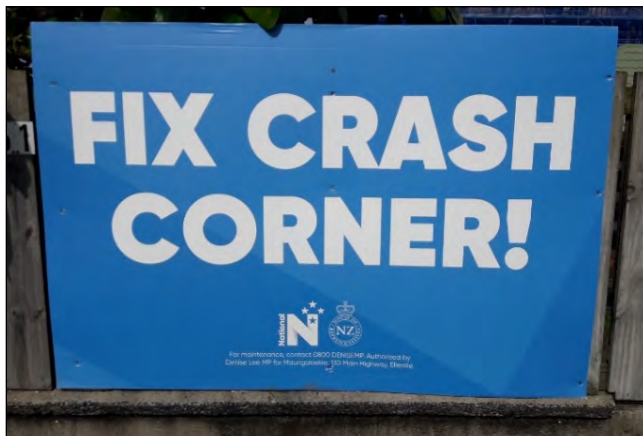
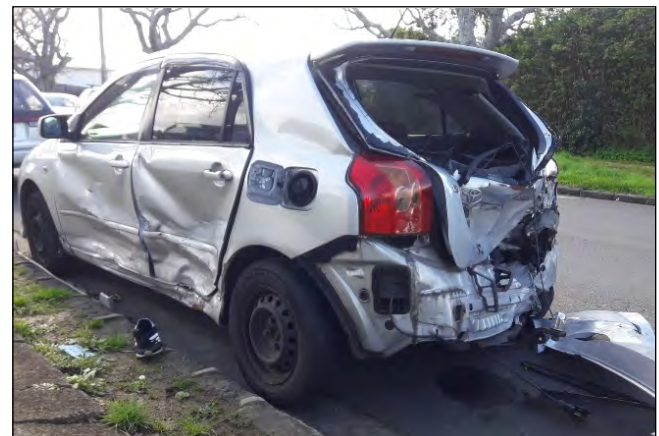
Figure 1. Fix Crash Corner community signage, and nearby vehicle debris

The intersection had been nicknamed ‘Crash Corner’ by the local residents, local community representatives, and a Member of Parliament (Figure 1). It had a recorded crash incidence of 54 crashes over five years (2015 – 2019), including 23 minor injury crashes and one serious injury crash. Glass and vehicle debris were a semi-permanent fixture on most corners of this intersection (Figure 1), as well as repeated private property damage.

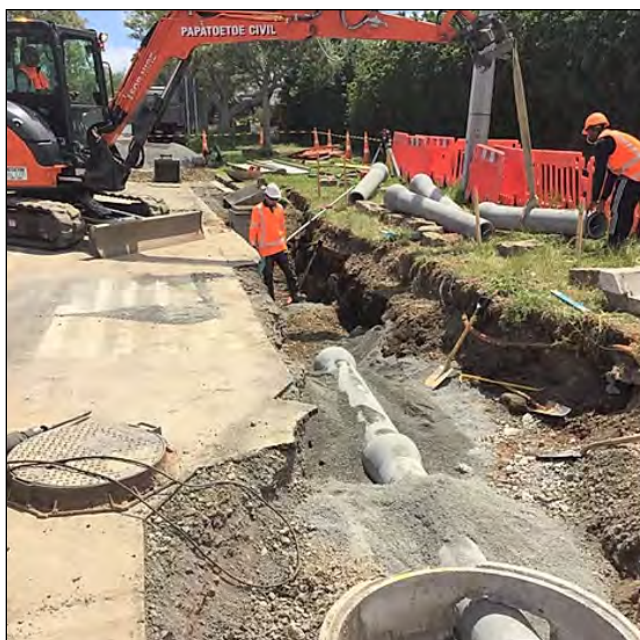
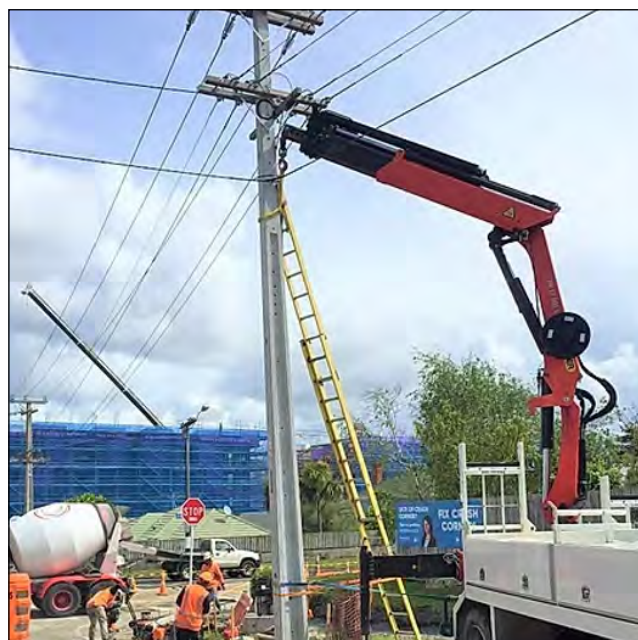
Figure 3. Roundabout under construction (left and right)

During construction, the kerbs and pavement design had to be adjusted due to excessively tough ground conditions, including basalt and volcanic rock at shallow depths. Also, there was an unexpected surprise in the form of 1950's Chorus cables at only 200mm depth. The design consultant managed to turn around revised geometric designs and pavement designs inside of three days, while construction progressed, eliminating project delays while construction continued (Figure 3).

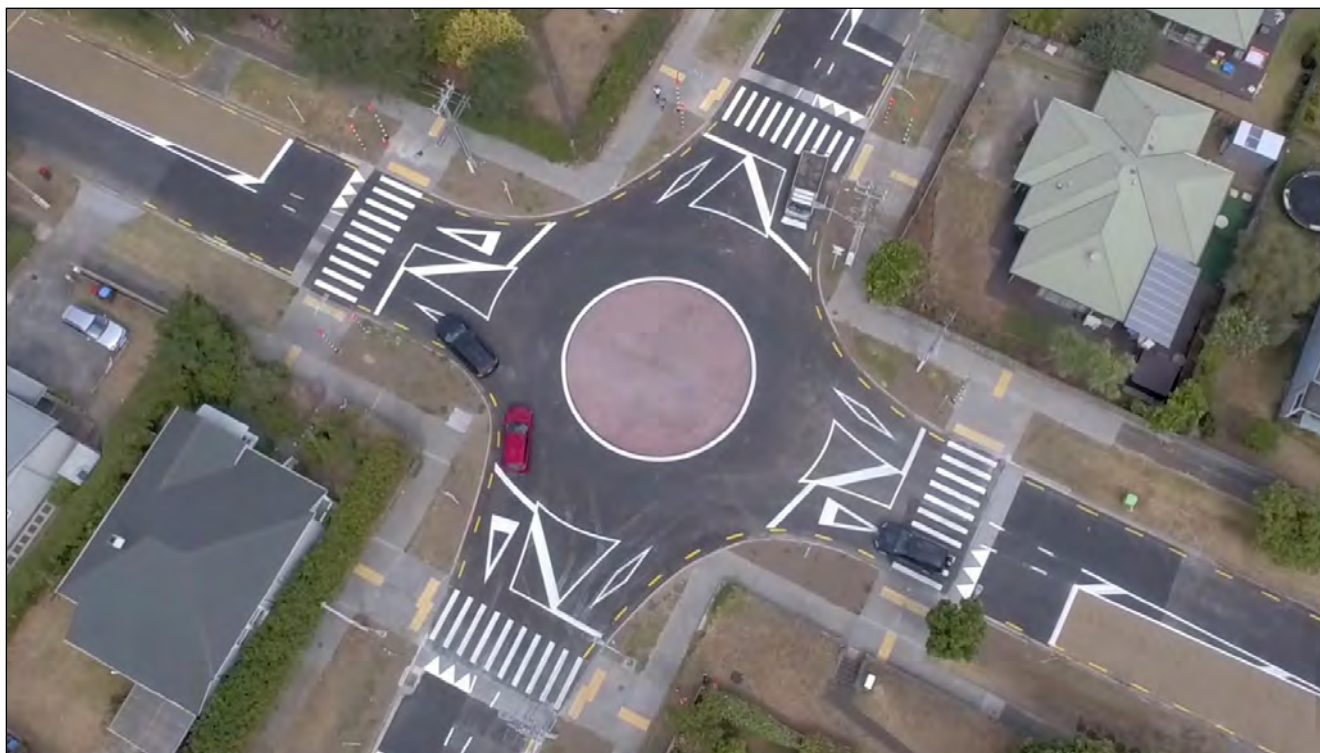
**Figure 6. Drone photo of the roundabout shortly after completion**

stress associated with on-going crashes at the junction, and having to repeatedly repair adjacent private property. There has been no anecdotal evidence suggesting that there have been recent crashes into street furniture or damage to private property along the boundaries since installation of the roundabout. Figure 6 illustrates the roundabout shortly after construction.
